## **NATIONAL TRANSPORTATION SAFETY BOARD**

### **VIDEO REVIEW SUMMARY**

**WPR18FA077**

| Aircraft: | Robinson R44, N7530R |

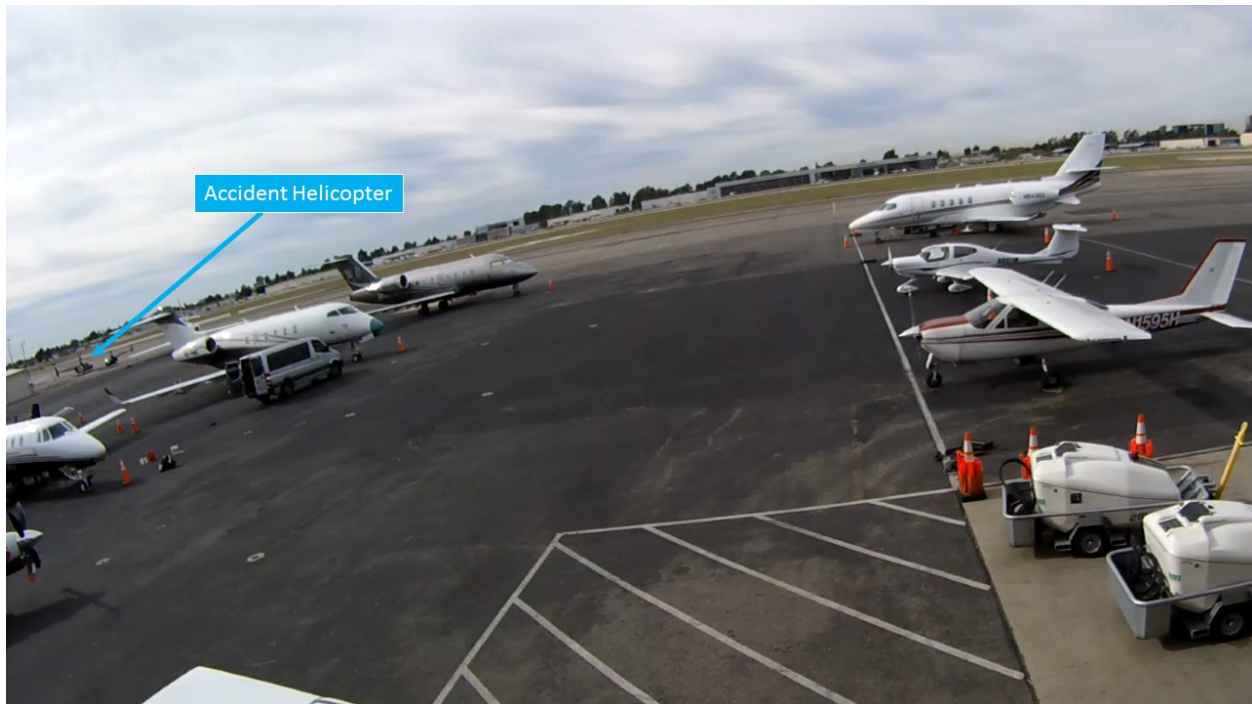
Figure 1: View from the surveillance camera.

Examination of surveillance camera recordings showed the helicopter stationary on the ramp, parked adjacent to another helicopter, before it slightly moved forward in a nose low attitude, lifted off, and rotated left. The helicopter continued to increase the nose low attitude and yaw to the right. The helicopter to briefly transition into a level attitude as it moved momentarily out of view behind an airplane. The tailboom became visible shortly after, in an elevated attitude, consistent with a nose low pitch. As the helicopter became visible, it appeared to be in a slight climbing left turn, remaining in a nose low attitude. The helicopter briefly descended and appeared to transition into a level attitude before it began an ascent. Shortly after, the helicopter was observed to continue the ascent, however, transition into a low now pitch as it traveled out of the frame of the camera.
